PRELIMINARY
**CREEKSIDE RESTORATION
MONITORING AND
MAINTENANCE PLAN**

**State and Hitchcock Center
Redevelopment Project**
3751-3771 State Street
Santa Barbara, California
March 18, 2006

CREEKSIDE RESTORATION MONITORING AND MAINTENANCE PLAN

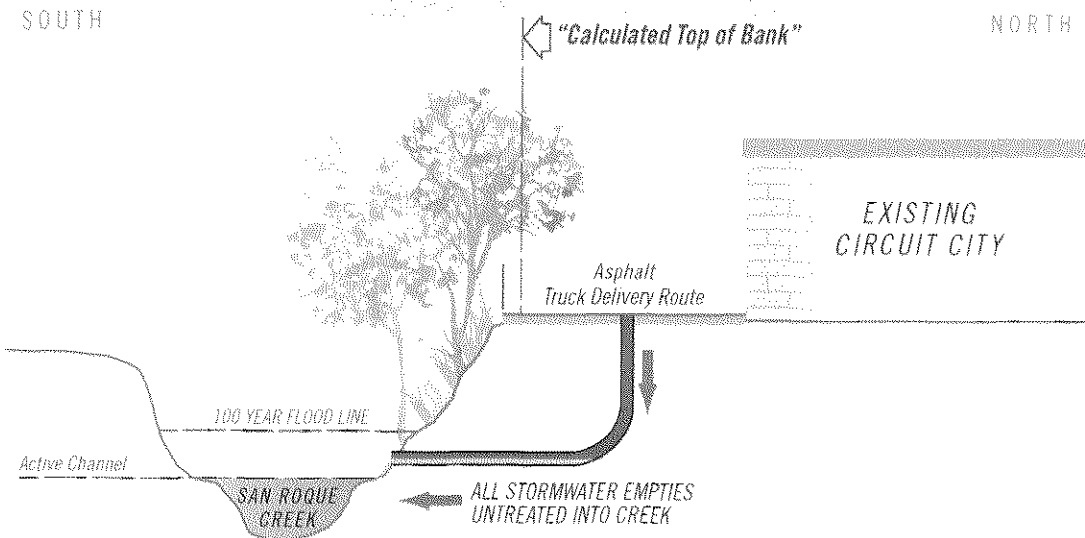
EXISTING CONDITIONS

- ① Developed Setback less than 20 feet in places.
- ② Asphalt Truck Delivery Route flanks creek.
- ③ Stormwater is untreated.

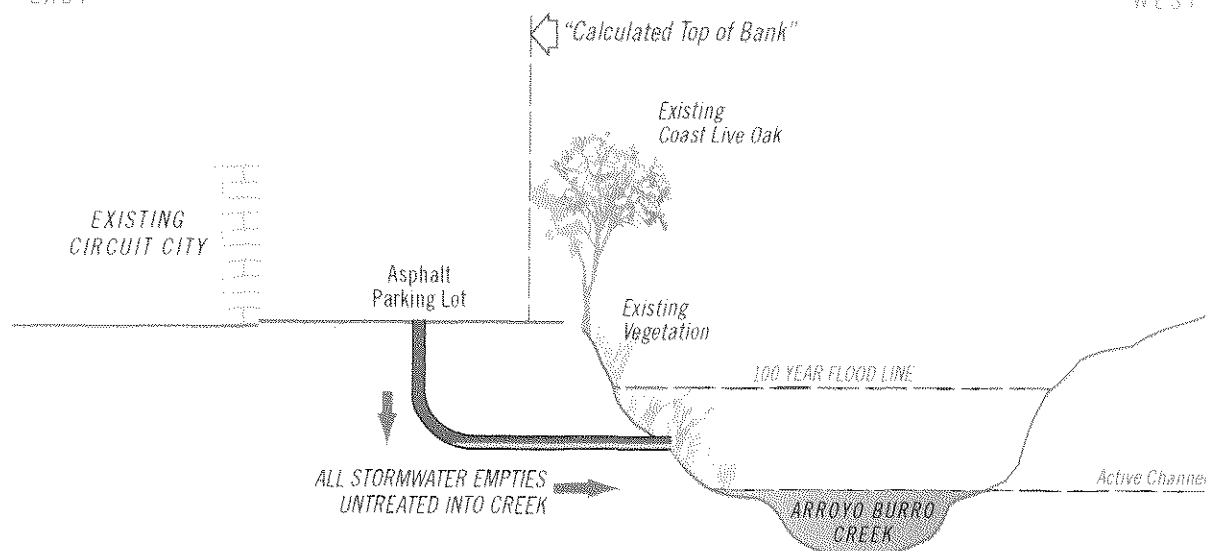
EXISTING CONDITIONS

- ① Asphalt Truck Delivery Route flanks creek.
- ② Stormwater is untreated.

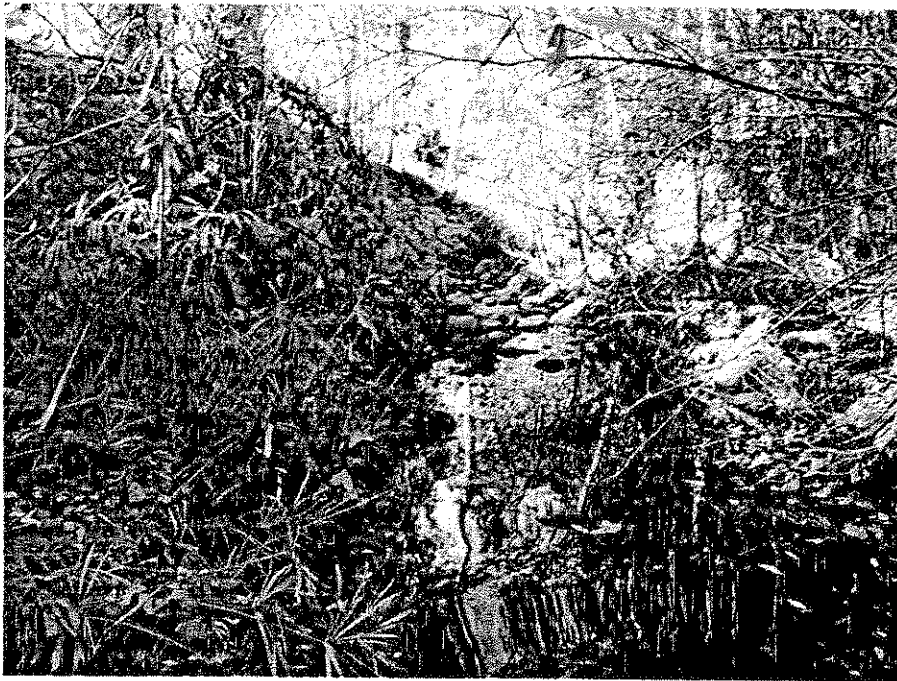
San Roque Creek appears to be in a later stage of evolution than Arroyo Burro Creek. It appears that most if not all of the potential degradation has occurred in the reach. Large boulders have been placed in the channel bottom at the upper end of the reach, which is likely to have a stabilizing factor. **Figure 3** shows that the stream bed profile in the lower reach is nearly flat and actually ponds low flow water. This is a clear indication that bed slope has stabilized and the reach is entering the fourth stage of channel evolution. The photos below show illustrate these points.

Photo 1. Low gradient reaches of San Roque Creek

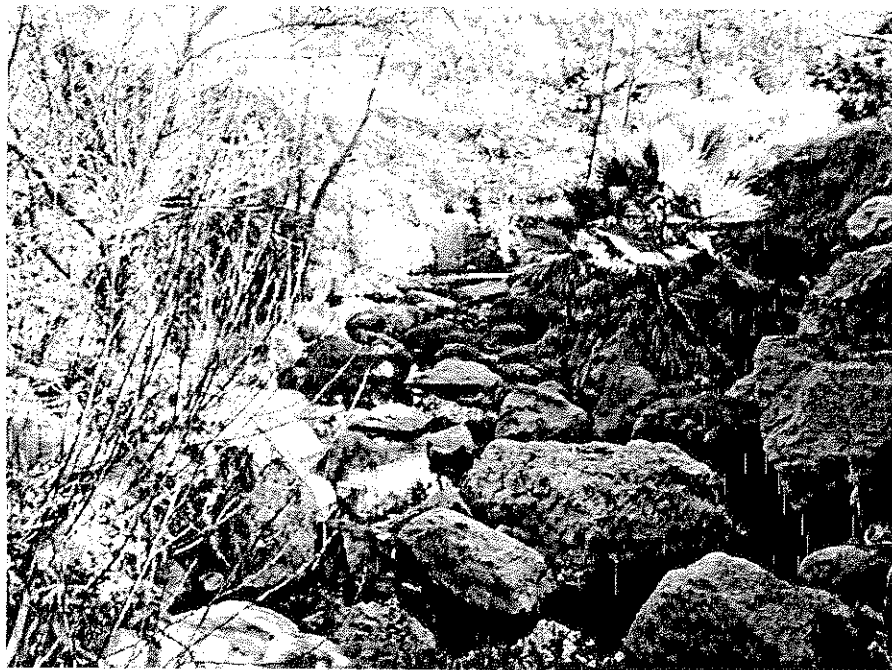
Photo 2. Placed boulders for bed stabilization in upper San Roque Creek

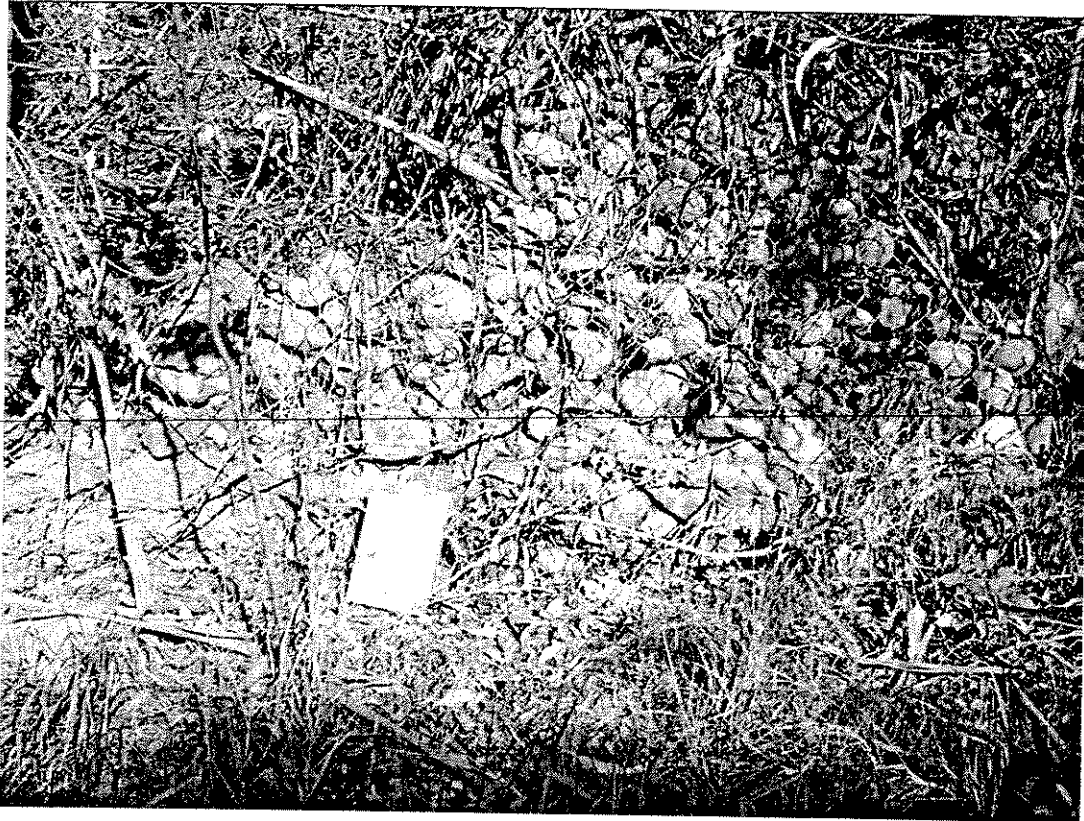
project. A small area at the base of the gabions is starting to degrade. Here the gabion basket wire has been worn away and the bottom of the basket (s) have lost their integrity. This does not appear to be a major problem but the area should be monitored to address any problems before they become large stability issues.

Photo 3. Base of gabions baskets showing broken bottoms – San Roque Creek

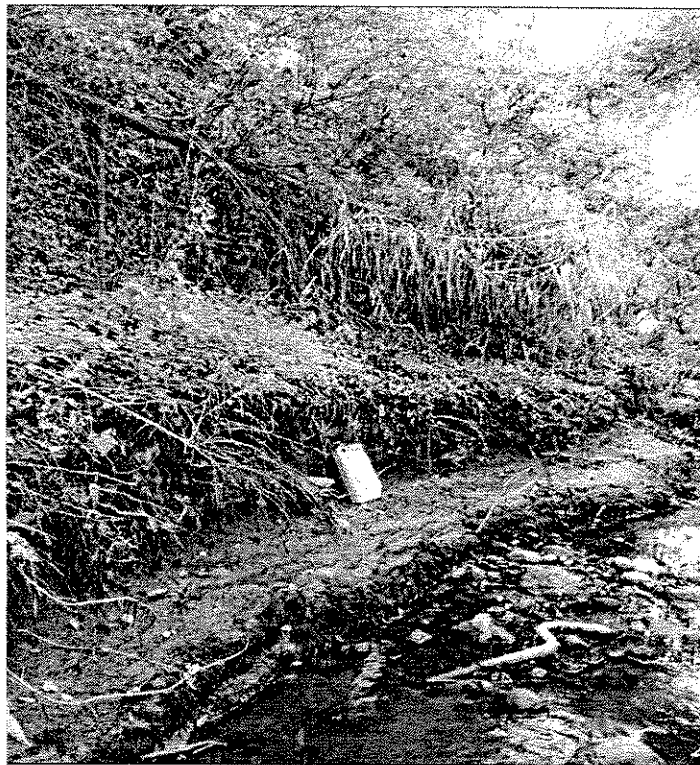
Because the bed material in Arroyo Burro Creek is predominantly sand for much of the project reach (300 feet out of 500 feet), we can roughly assume a stable long-term slope of the channel would be in the 0.3 to 0.5 percent range. The current slope between the Hope Street culvert and State Street is approximately 2.46 percent. Figures 2 and 3 show what could be the potentially stable slope given data that we have and one representative cross section. It appears that channel will continue to degrade between 6 inches to 3.5 feet over the long term if the bed load composition remains the same. The largest amount of degradation is likely to be seen immediately below the State Street culvert outlet. There is strong evidence that this has occurred and/or is currently occurring in the system. The perching of the State Street culvert and the current placement of boulder revetment at the outlet are evidence of recent channel degradation. The photos below show signs of recent degradation in the channel.

Photo 4. Evidence of recent channel degradation below State Street culvert

Option 3. Reestablish a stable steeper gradient. This option would entail recreating the previous 2 percent channel bed slope. This would be accomplished by placing dirt and rock fill material. The rock would be used to stabilize the channel bed. Reestablishing the historic grade would have several positive benefits. It would minimize top of slope retreat, reduce existing erosion, and reduce the potential for future geotechnical failures of the bank. This option is therefore the preferred stabilization option and is described in more detail below.

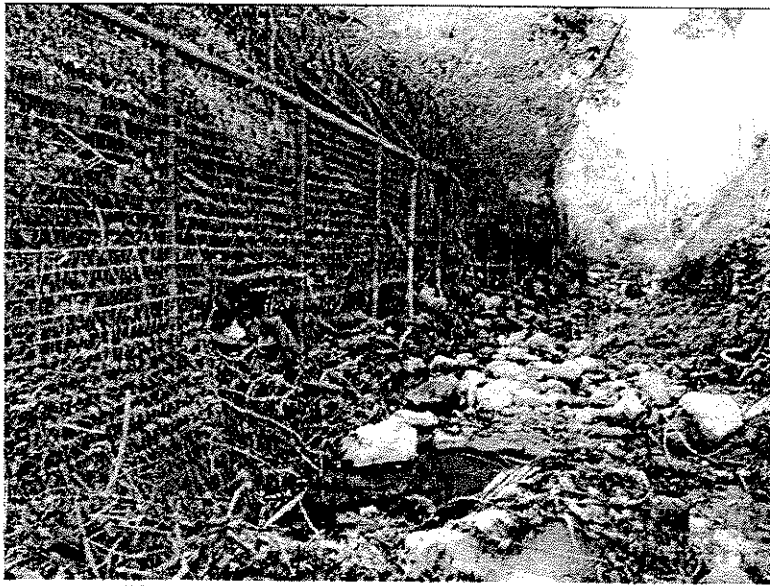
Photo 5. Degradation at the pipe and wire revetment

This erosion process will likely in time drive channel widening, potentially threatening the mature bank top oak trees and top of bank facilities. The existing pipe and wire revetment is aging and will eventually fail removing or reducing the toe support it is currently giving to the channel bank. Therefore it would not be infeasible that over time the bank top on the project site would retreat 10 feet from its present location if the bed elevation were to remain at its present location.

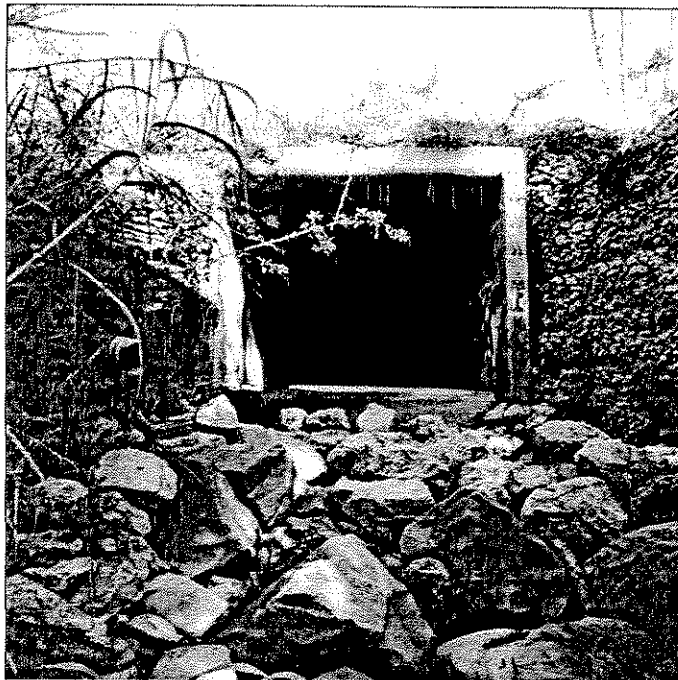
Photo 6. Boulders placed at culvert outlet to stabilize degrading bed

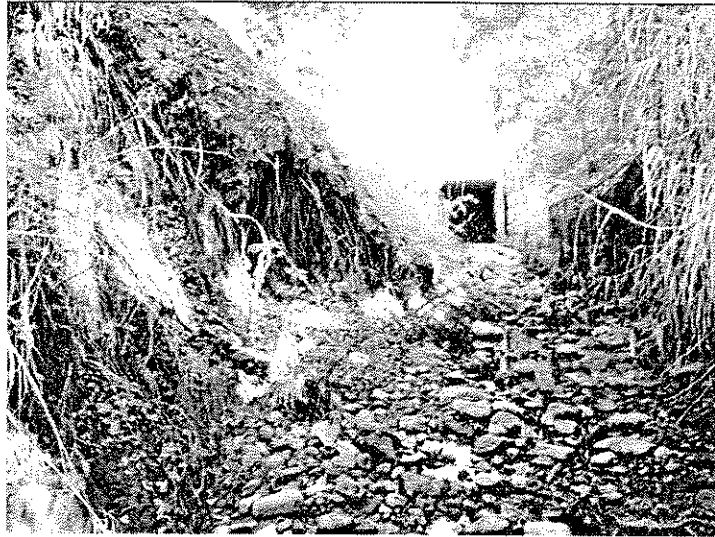
The creek banks along Arroyo Burro Creek appear to be steep and stable in the short term. At present slopes are on average 1(H): 1(V). A typical natural semi-stable slope would be in the 1.5 (H): 1(V). As the channel continues to degrade the natural tendency for the channel is to widen its top of banks through slumps and geotechnical failures. **Photo 7** shows one of these failures occurring opposite the project site.

Photo 7. Bank failures in Arroyo Burro Creek, looking towards State Street
